**Post Opening Road Safety Audit Report**

# Collins Street, Hobart TAS – Bicycle Lane Trial

**Project Number** 260016

**Final2 Report** 21/08/2026

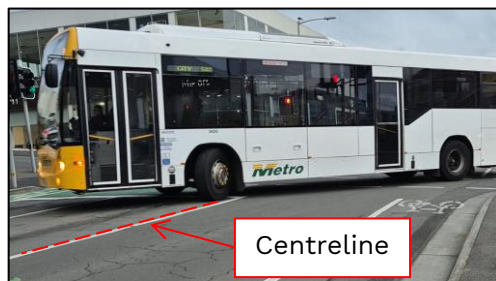
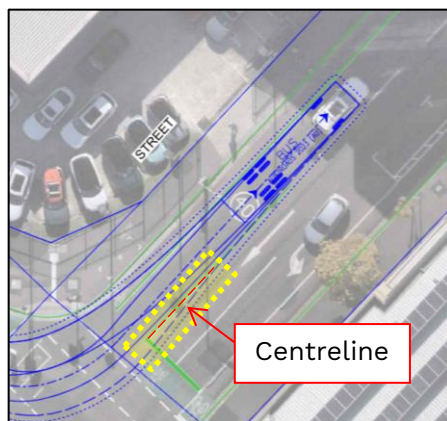
| No | Audit findings | <b>Audit recommendations</b><br>(P) = Primary<br>(S) = Supporting<br>(O) = Other | <b>Risk rating / safe system energy</b> | <b>Client response</b> | |
|---|---|---|---|---|---|
| 1.4. | <p>Buses turn left from Barrack Street into Collins Street from the central lane and overhang the centreline on Collins Street when turning.</p> <p>Review of pre-installation of the bicycle lane aerial photos indicate that to accommodate the separate left turn lane, the centreline of Collins Street was relocated and reduced the width of the departure lane by approx. 1.0 m.</p> <p>Swept path analysis (refer to Appendix 3 – Swept path assessment) indicates that prior to the works, buses were still required to turn from the central lane. However, buses can no longer complete the turn without crossing the centreline.</p> <p>There is a risk that turning buses will:</p> <ul style="list-style-type: none"> <li>— strike a vehicle propped at the hold line on Collins Street</li> <li>— mount the kerb to avoid a car propped at the hold line and strike a pedestrian waiting at the crossing.</li> </ul> | <p>Widen the departure lane on Collins Street to ensure buses can turn left from Barrack Street into Collins Street without crossing the centreline or mounting the kerb (P)</p> <p>Consider rerouting the bus (P)</p> | <p>Likelihood:<br/>Unlikely</p> <p>Severity:<br/>Fatal</p> <p><b>Risk rating:<br/>EXTREME</b></p> <p>Safe system energy:<br/>Above tolerance</p> | | |

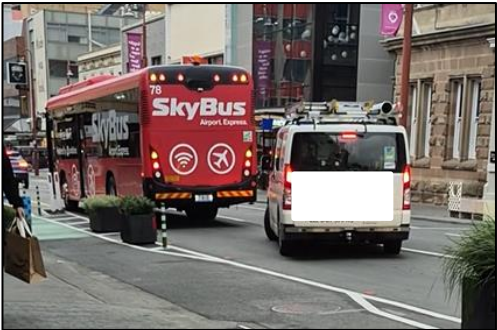
| No | Audit findings | Audit recommendations<br>(P) = Primary<br>(S) = Supporting<br>(O) = Other | Risk rating / safe system energy | Client response | |
|---|---|---|---|---|---|
| 1.5. | <p>The Airport Skybus stops at the inline bus stop southwest of Murray Street. The Skybus takes longer for passengers to enter and exit the bus as passengers have baggage to load or unload.</p> <p>As the bus stop is inline, general traffic needs to wait until the bus leaves the stop which may take several minutes, depending on the number of passengers.</p> <p>During the site inspection, it was observed that the Skybus took just under one minute to leave the bus stop and trailing cars were observed to drive on the wrong side of the road to bypass the stopped bus, increasing the risk of head on collisions.</p> | Relocate the Skybus bus stop to a different location where the bus will not disrupt traffic flow (S) | <p>Likelihood:<br/>Possible</p> <p>Severity:<br/>Moderate</p> <p><b>Risk rating:<br/>HIGH</b></p> <p>Safe system energy:<br/>Below tolerance</p> | | |

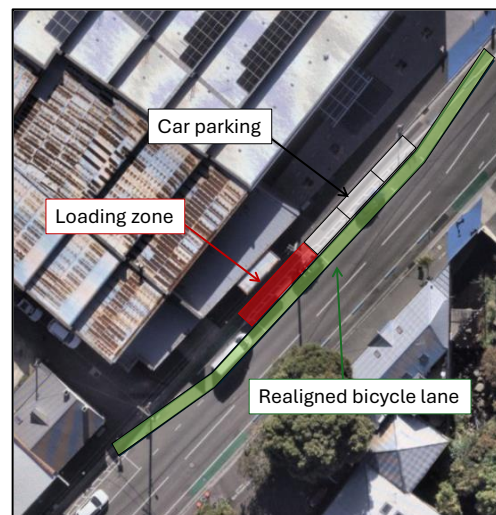
- 1.7. There is a wholesale premises at the southwestern end of Collins Street which does not have on-site loading facilities, relying on the on-street loading. Loading activity requires forklifts to transport goods between the premise and the delivery vehicle.

The introduction of the on-road bicycle lanes has placed cyclists between the delivery vehicles and the premise – requiring forklifts to occupy the bicycle lanes for loading/unloading. The loading activities pose a safety risk to cyclists travelling in the bicycle lane.

Furthermore, as the site is located at the bottom of a hill, cyclists are approaching at speed increasing the severity if a collision occurred.

Consider realigning the bicycle lane to position the loading area/car parking next to the kerb to separate loading activity and cyclists (P)

- warning pavement marking in the bicycle lane to encourage cyclists to slow down on approach to the conflict point (S)
- contrasting pavement at the loading location to highlight the conflict point (S)

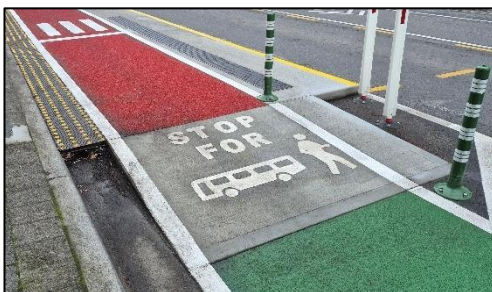
- 1.8. The inline bus stop features a raised platform for DDA compliance. The ramp connecting the bicycle lane to the raised platform does not extend the full width of the platform. There is a risk that a cyclist may miss the ramp and fall from their bicycle.

Provide a ramp between the existing kerb and the edge of the ramp. The ramp will need to be grated for drainage purposes (S)

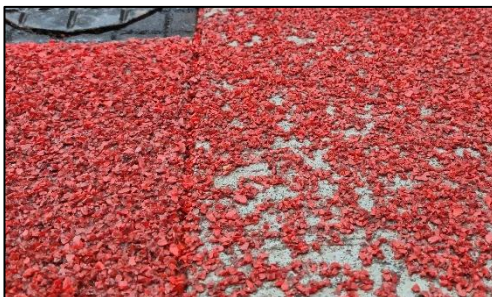
The red surface treatment of the bus stop is made of a rough stone material which would increase severity if a cyclists falls.

Replace the existing red surface treatment with a red fine grain sand surface treatment (S)

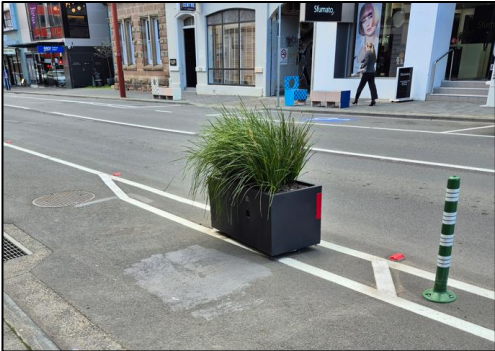
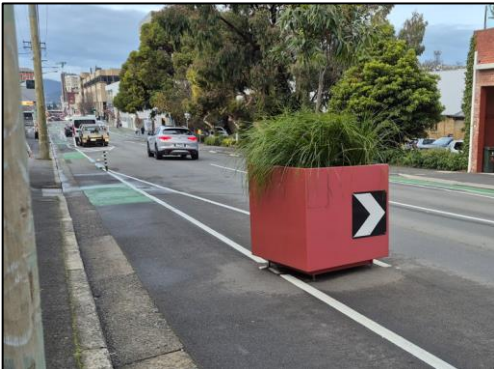
| No | Audit findings | Audit recommendations<br>(P) = Primary<br>(S) = Supporting<br>(O) = Other | Risk rating / safe system energy | Client response | |
|---|---|---|---|---|---|
| 1.10. | <p>Planter boxes have been installed along the edge of the bicycle lane to separate bicycles from traffic. These planter boxes are not secured to the ground with evidence that some planter boxes have shifted from their original location.</p> <p>There is a risk that vehicles will strike the planter boxes and will encroach into the bicycle lane, posing a striking hazard.</p> | Consider removing or securing the planter boxes to ensure they cannot dislodge and pose a striking risk to cyclists (S) | <p>Likelihood:<br/>Rare</p> <p>Severity:<br/>Minor</p> <p><b>Risk rating:<br/>LOW</b></p> <p>Safe system energy:<br/>Below tolerance</p> | | |

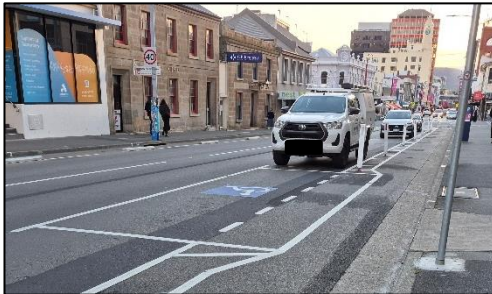
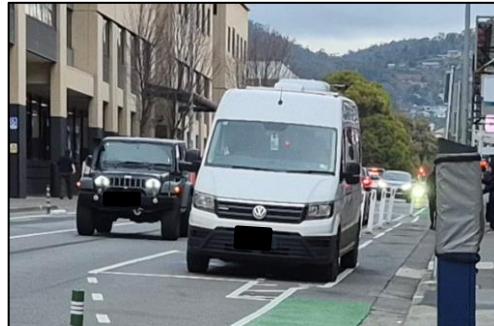
- 1.12. DDA car parking is line marked into the bicycle lane to achieve the space width required under AS2890.2.

The line marking provides the 3.2 m width of the car parking space but provides a dashed line to indicate where drivers should park to maintain the width of the bicycle lane.

Cars were observed parking over the indicative line, reducing the effective width of the bicycle lane and increasing the likelihood of a dooring collision with the lack of a buffer zone.

There is insufficient road width to provide a compliant DDA space and adequate bicycle lane width.

Consideration should be given to installing green pavement treatment within the bicycle lane adjacent to the DDA space to increase awareness of the cyclists at the conflict point (S)

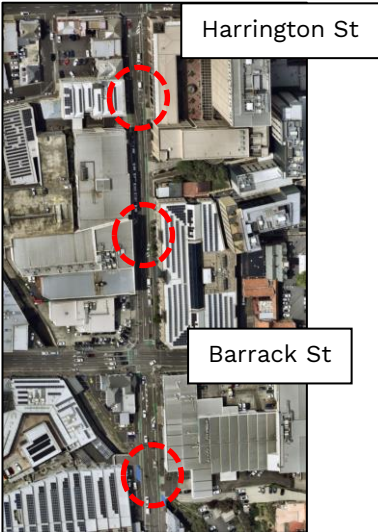
| No | Audit findings | Audit recommendations<br>(P) = Primary<br>(S) = Supporting<br>(O) = Other | Risk rating / safe system energy | Client response | |
|---|---|---|---|---|---|
| 1.16. | <p>Traffic laterally shifts at several locations along Collins Street where on-street parking alternates between either side of the road.</p> <p>The lateral shifts appear relatively abrupt for the posted speed limit and may be difficult for drivers to negotiate. This may increase the risk of sideswipe and off-carriageway type crashes.</p> | <p>Review the geometry of the lateral shifts and ensure that it is appropriate for the posted speed limit and is consistent with Austroads Guide to Road Design Part 3 (AGRD3) (S)</p> | <p>Likelihood:<br/>Possible</p> <p>Severity:<br/>Insignificant</p> <p><b>Risk rating:<br/>LOW</b></p> <p>Safe system energy:<br/>Below tolerance</p> | | |

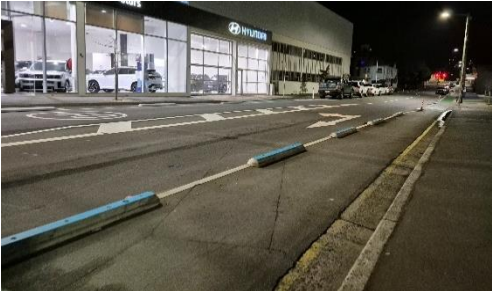
| No | Audit findings | <b>Audit recommendations</b><br>(P) = Primary<br>(S) = Supporting<br>(O) = Other | <b>Risk rating / safe system energy</b> | <b>Client response</b> | |
|---|---|---|---|---|---|
| 1.17. | <p>The top of the concrete separators have been painted blue which delineate the separators during the day. However the separators are not clearly visible in dark conditions.</p> <p>Bollards with reflective tape have been installed at the start of the separated bicycle lanes to delineate the separators, however there is still a risk that cyclists entering between the separators may strike the separators or pedestrians crossing midblock may trip over the separators.</p> | <p>Consider the following:</p> <ul style="list-style-type: none"> <li>— install reflective bollards on all separators (S)</li> <li>— paint the separator in retroreflective paint (preferably yellow colour) to highlight the separator and ensure a reflective bollard is provided at the start of the separators (S)</li> </ul> | <p>Likelihood:<br/>Possible</p> <p>Severity:<br/>Minor</p> <p><b>Risk rating:<br/>MEDIUM</b></p> <p>Safe system energy:<br/>Below tolerance</p> | | |
