**Post Opening Road Safety Audit Report**

# Collins Street, Hobart TAS – Bicycle Lane Trial

**Project Number** 260016

**Final2 Report** 21/08/2026

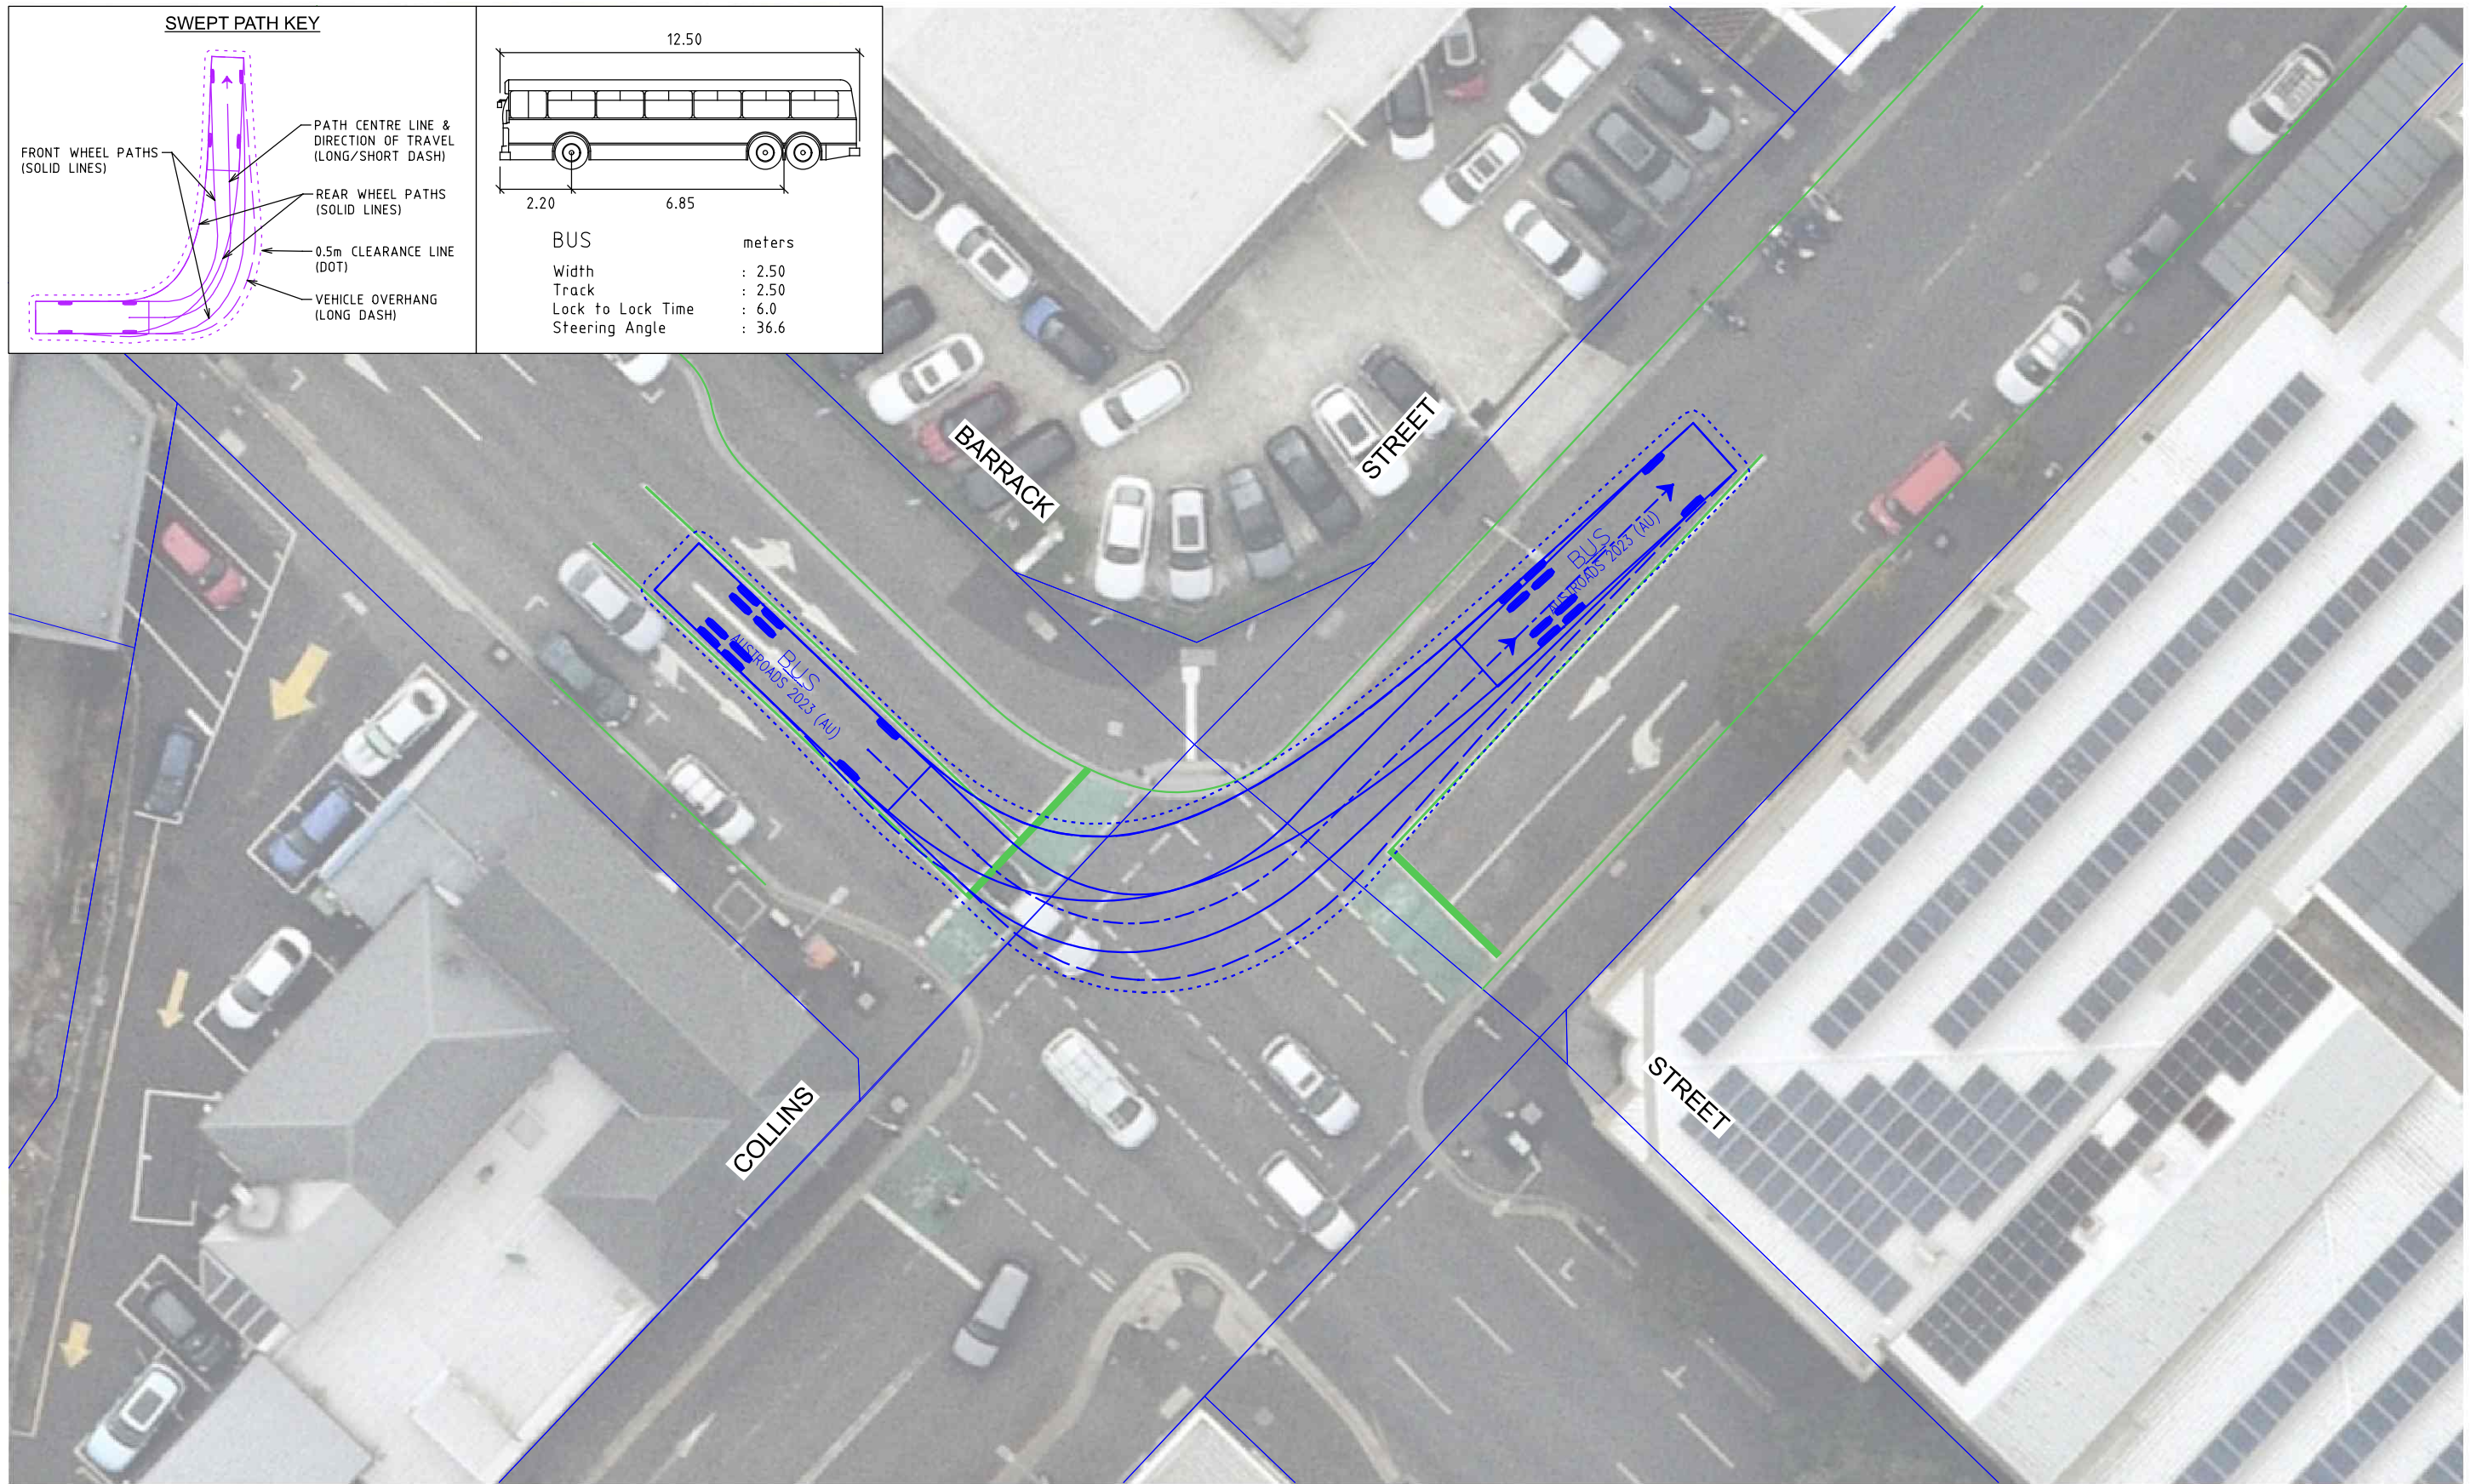
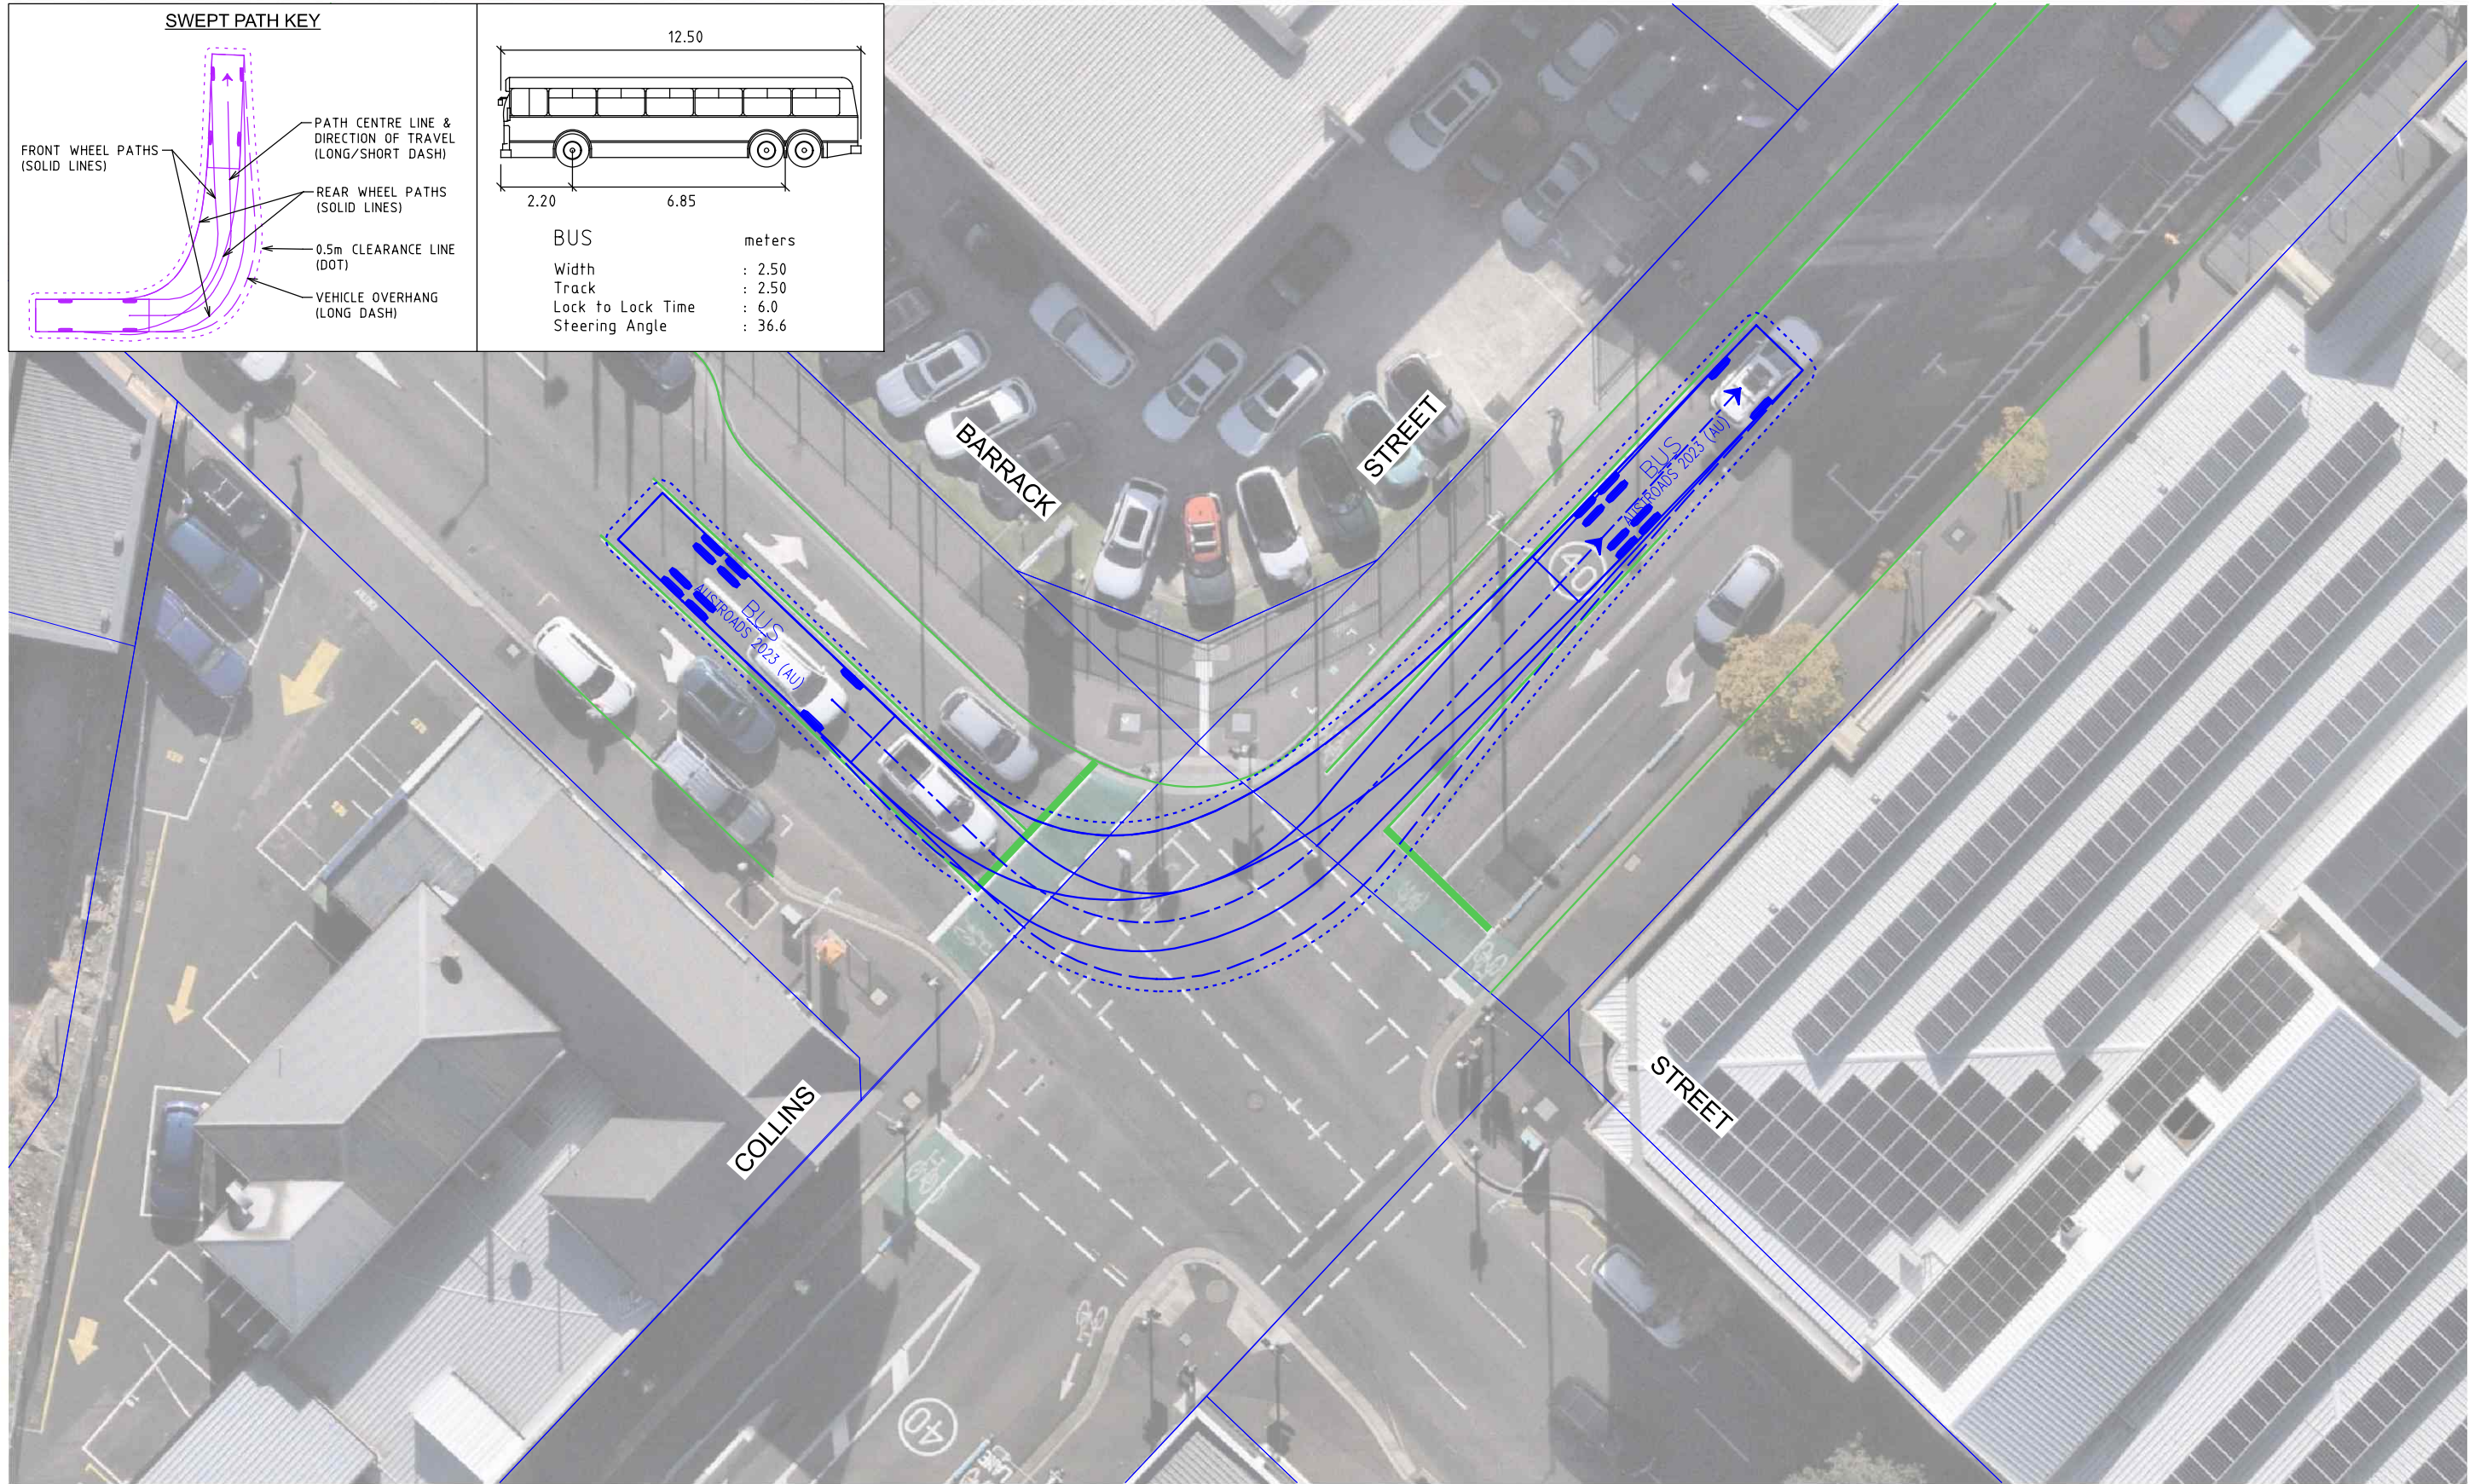
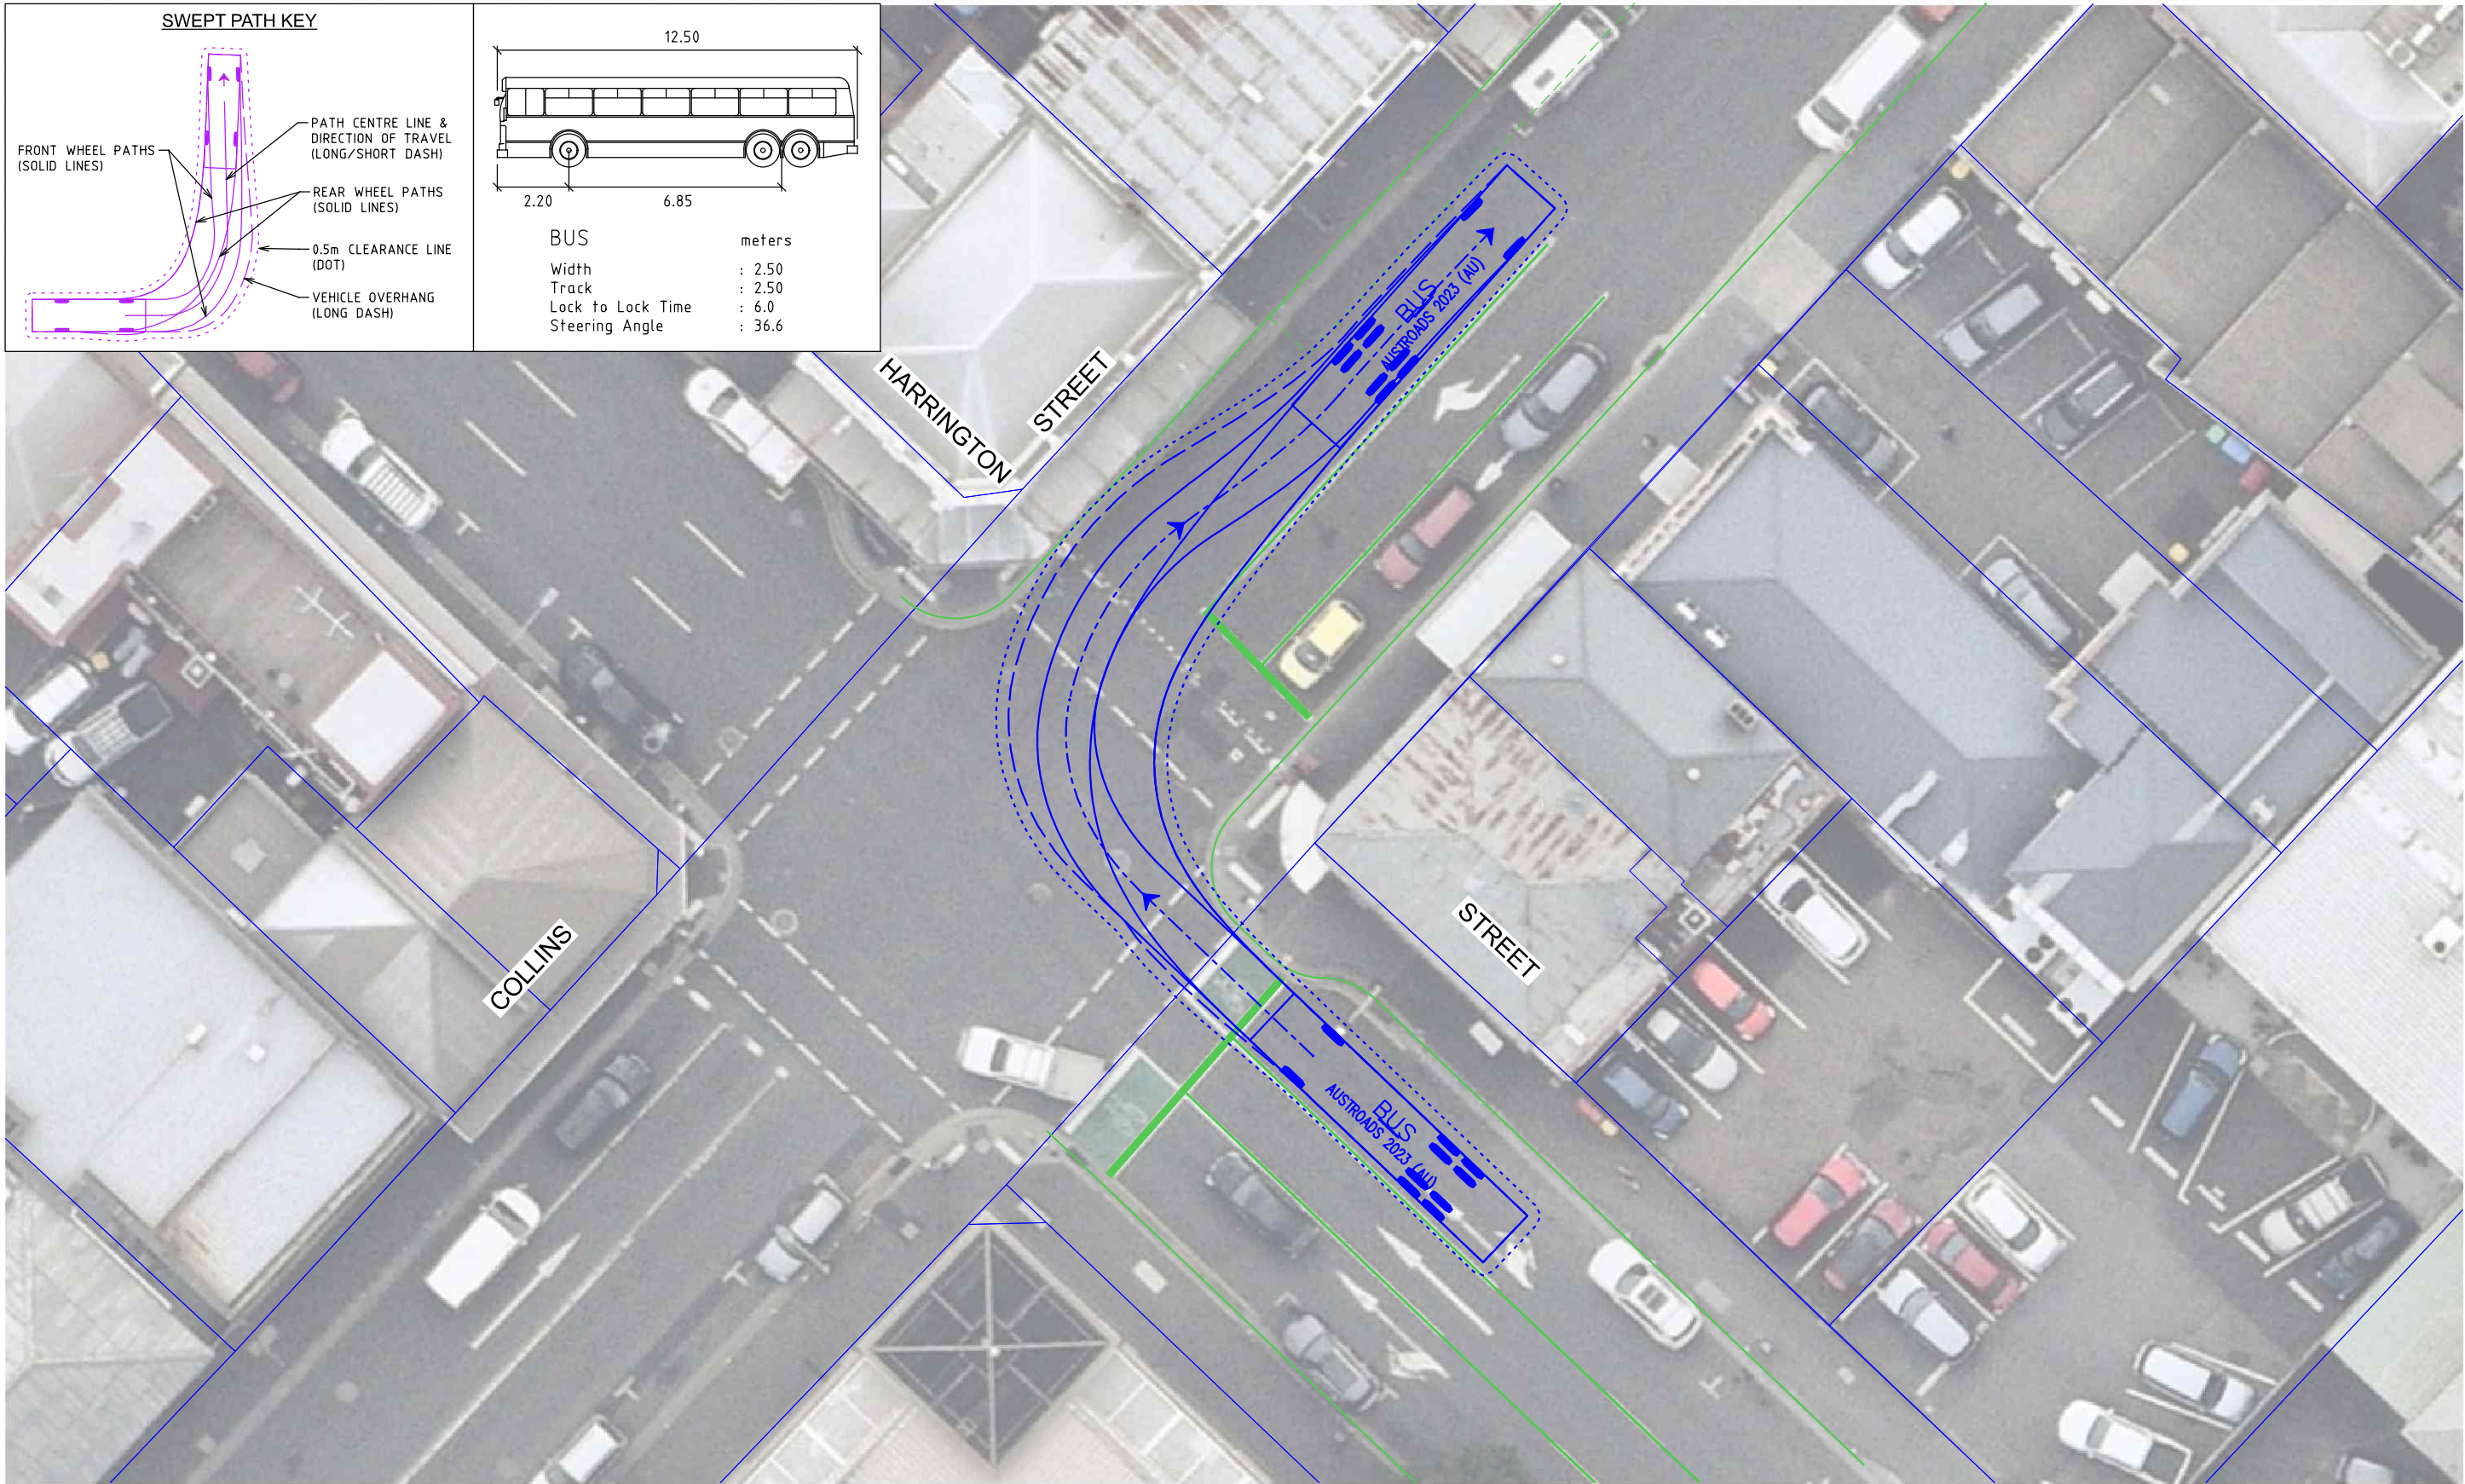
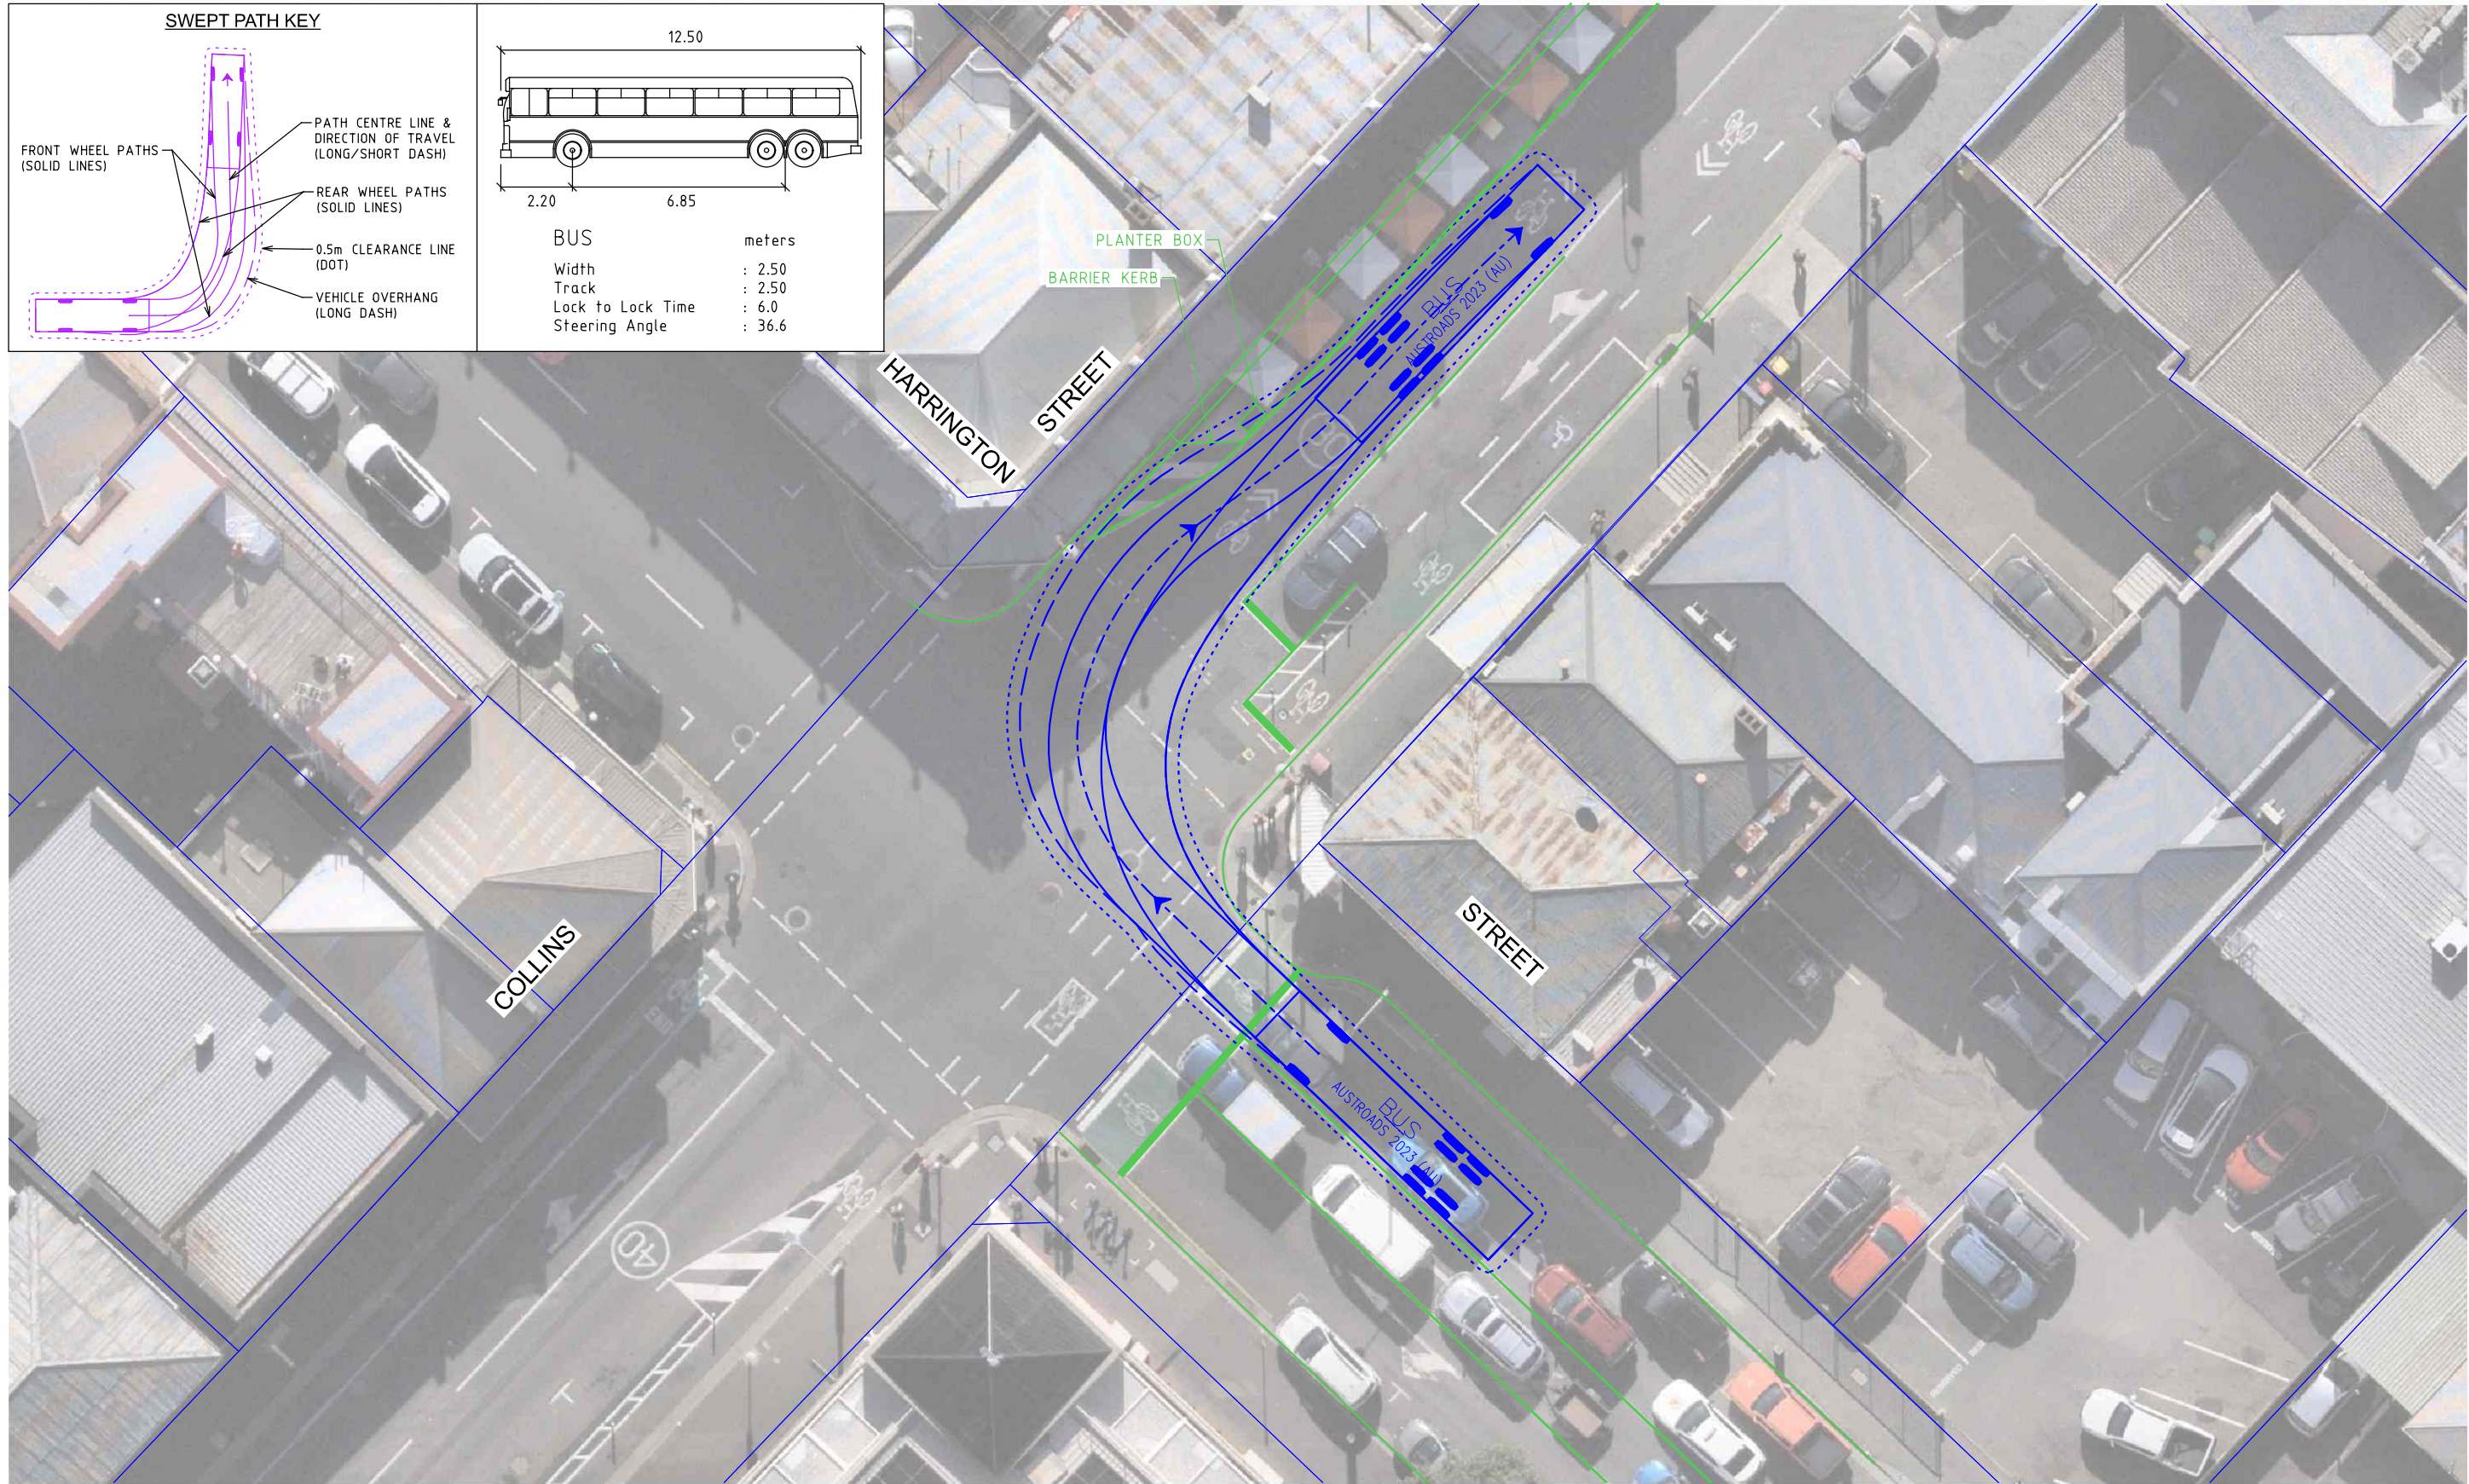
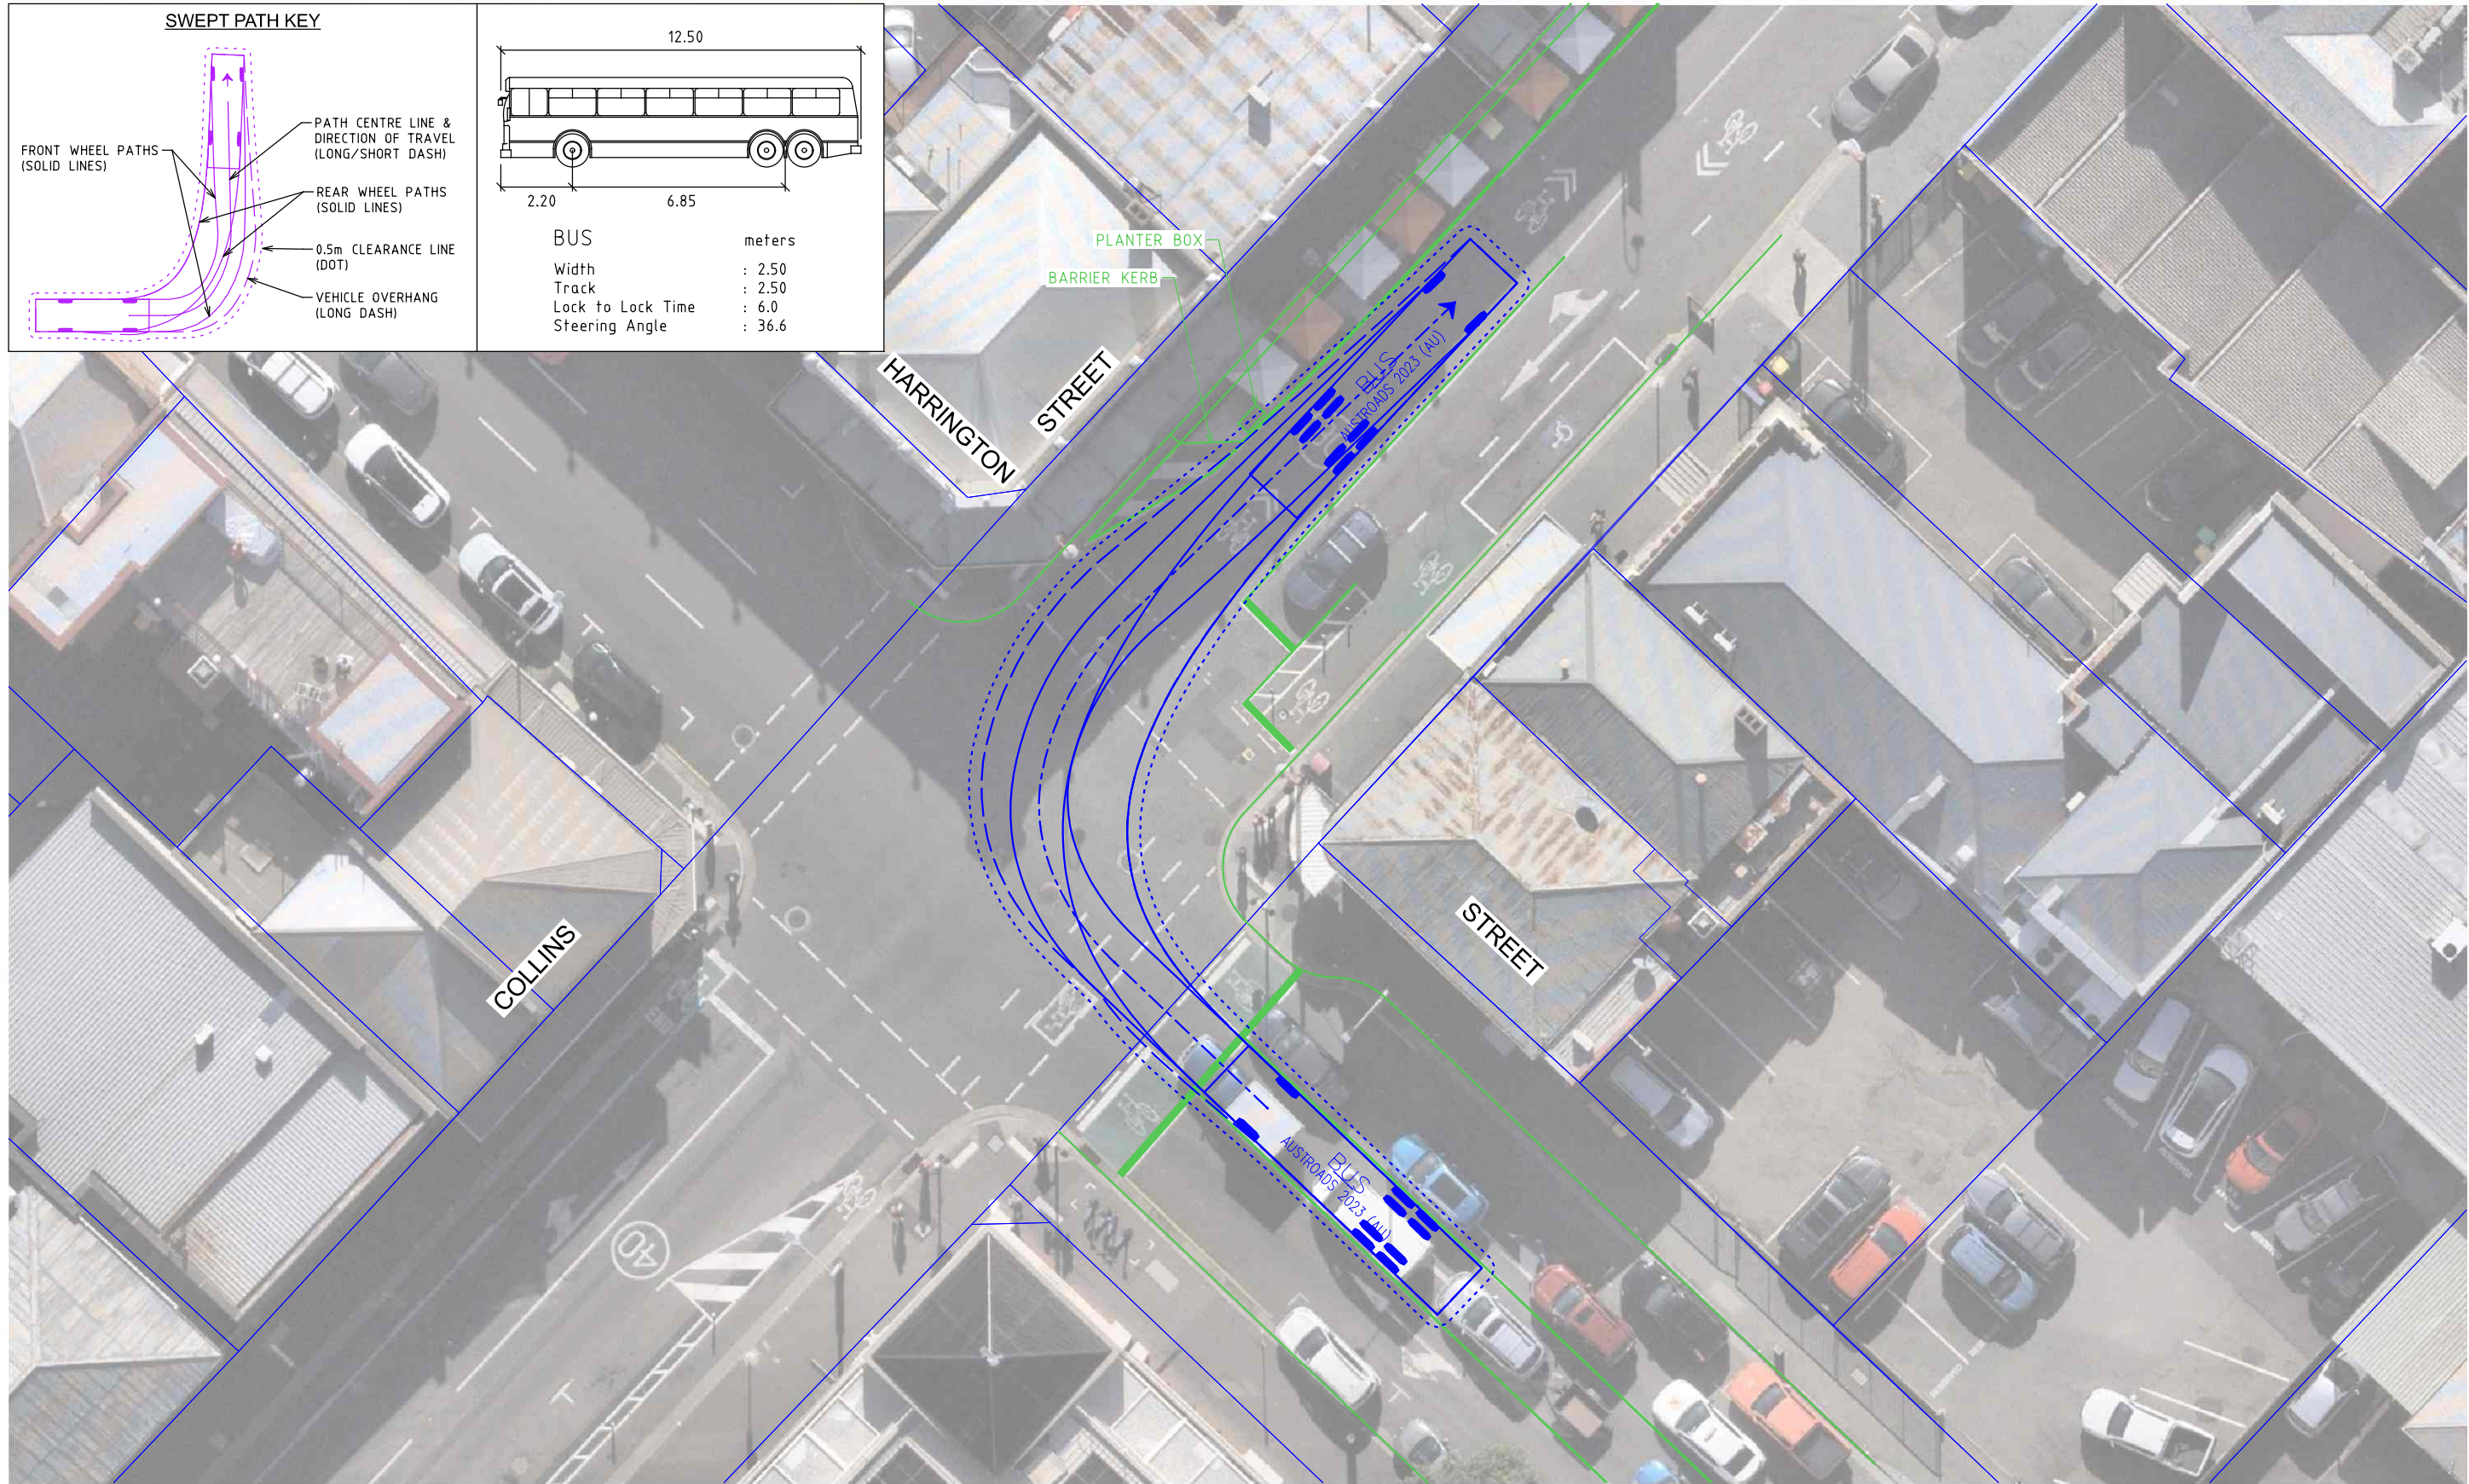
## **Appendix 3 – Swept path assessment**

| No | Audit findings | Audit recommendations<br>(P) = Primary<br>(S) = Supporting<br>(O) = Other | Risk rating / safe system energy | Client response | |
|---|---|---|---|---|---|
| 1.3. | <p>Buses turn right from Harrington Street into Collins Street. Buses were observed turning from the central lane and requiring to significantly slow down to complete the turn.</p> <p>Swept path assessment (refer to Appendix 3 – Swept path assessment) indicates that prior to the installation of the outdoor dining area, buses could turn into Collins Street from the kerbside traffic lane.</p> <p>The impact to the bus turning swept path increases the risk of:</p> <ul style="list-style-type: none"> <li>— buses side swiping roadside furniture or southbound vehicles at the hold line on Collins Street</li> <li>— rear end collisions for trailing vehicles on Harrington Street who are not expecting buses to significantly slow down during their turn.</li> </ul> | Remove part of the outdoor dining kerb outstand to ensure buses can turn right from Harrington Street into Collins Street from the kerbside lane (P) | <p>Likelihood:<br/>Likely</p> <p>Severity:<br/>Insignificant</p> <p><b>Risk rating:<br/>MEDIUM</b></p> <p>Safe system energy:<br/>Below tolerance</p> | | |
